VENTURA COUNTY GOVERNMENT
CENTER
GENERAL SERVICES AGENCY
GROUNDS DEPARTMENT
WATER CONSERVATION STRATEGY
AUGUST 07, 2014

WATER CONSERVATION STRATEGY

GENERAL SERVICES AGENCY GROUNDS DEPARTMENT
WATER CONSERVATION STRATEGY

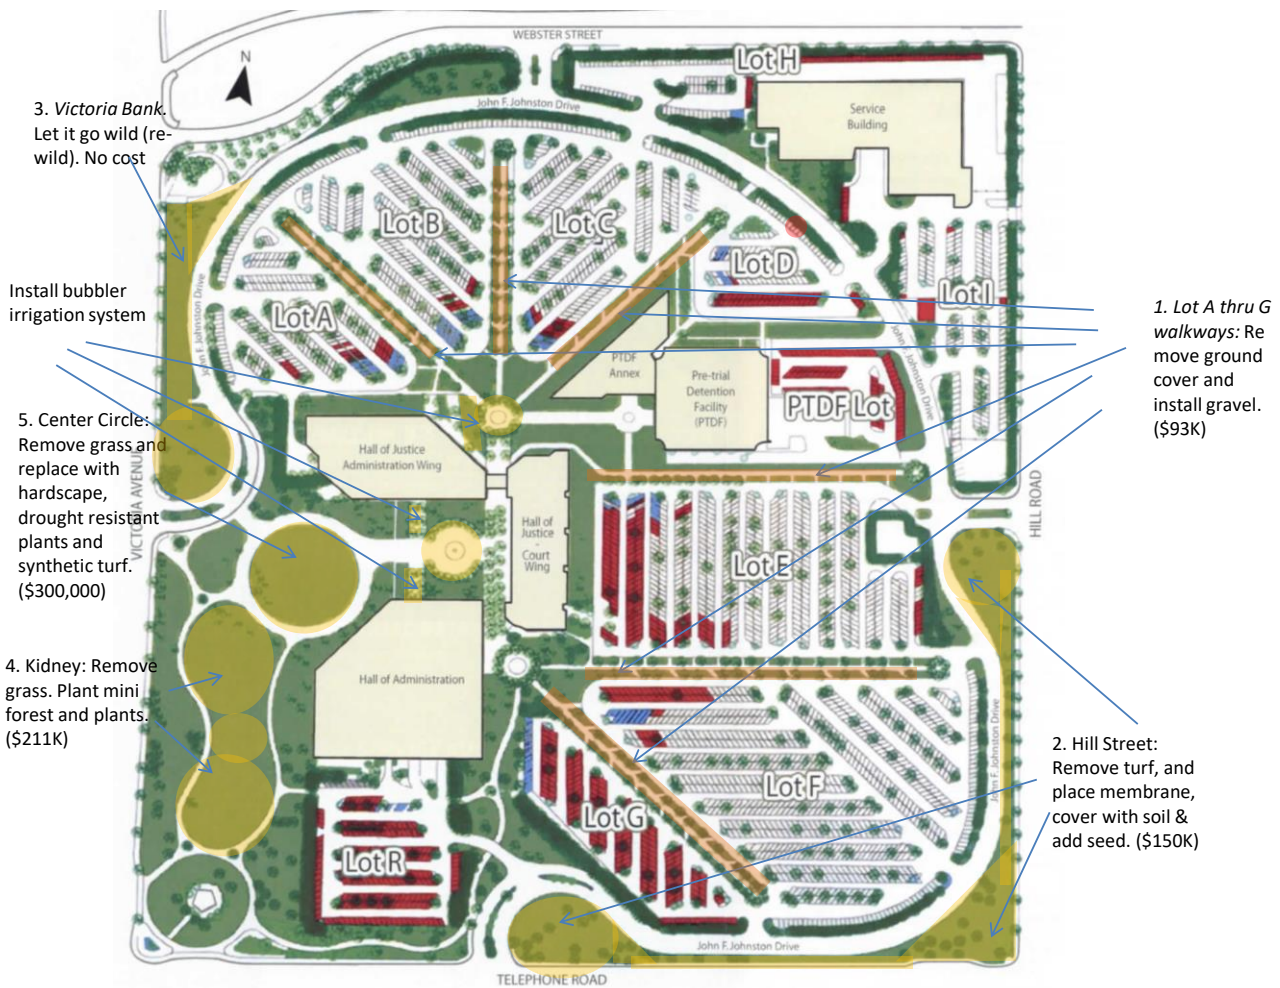
Figure 2-2

4. **Kidney:** Plant a mini forest around the perimeter of the kidney. The Kikuyu grass will be removed and replaced with more drought resistant plants and trees shown in the design and listed in APPENDIX (3). As landscape matures the watering will be discontinued. It will take approximately six (6) months. The irrigation landscape is reduced by 105,400 ft² = 2.42 acres. The water saved will be 8.42 acre-feet per year. The project cost is approximately \$225,000. The design for this drawing can be found in appendix 3. In spite of the savings from the lack mowing required, the weeding and herbicide treatment will increase. The annual cost will be \$22,325.

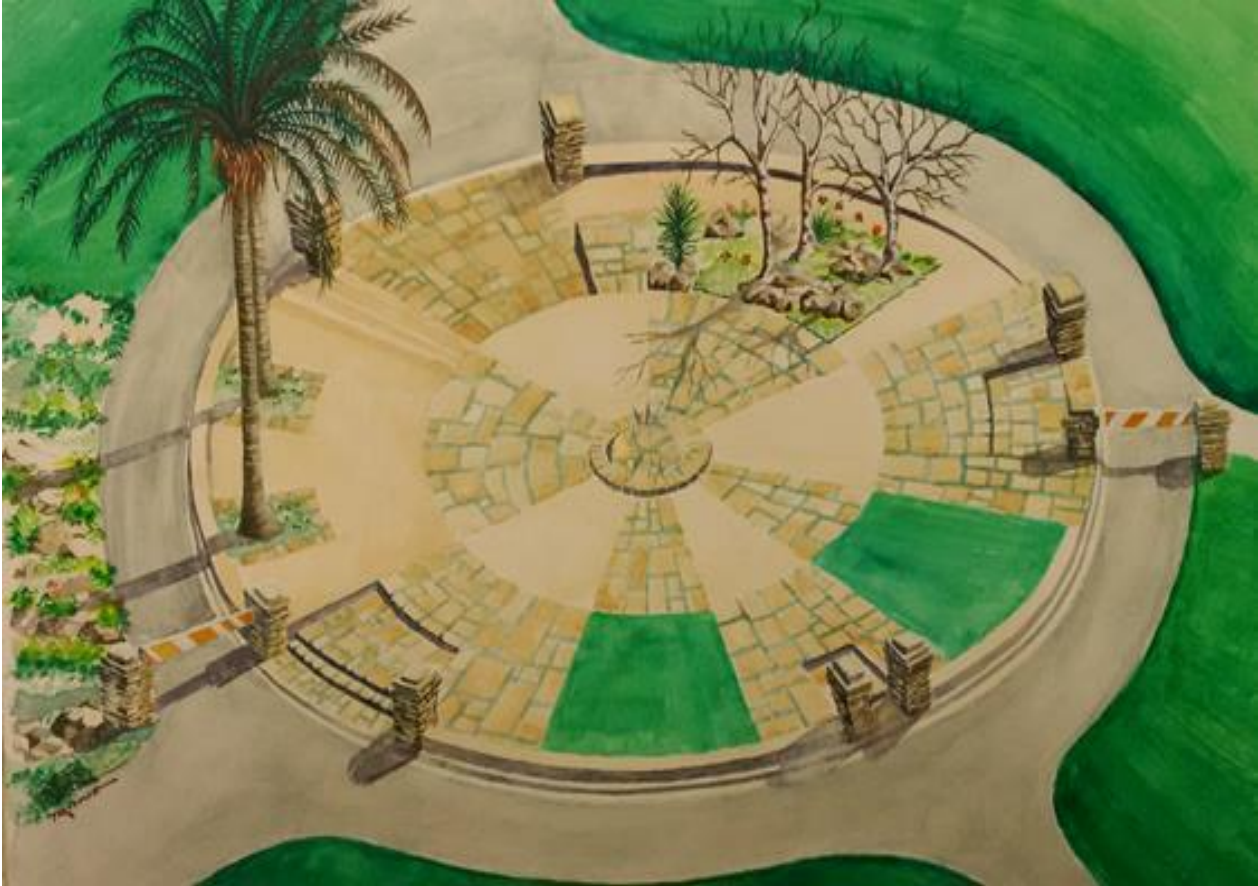
5. **Center Circle:** Remove the turf at the circle and replace with a plaza. See Figure 2-3 for details. The turf will be synthetic in type. The landscape will be a waterless demonstration garden. This will

reduce the landscape by 22,658 ft² = 0.52 acre and reduce irrigation by 1.81 acre-feet per year. The cost of installation of stamped concrete is approximately \$271,896 (\$12/ft²). The landscape and posts cost is \$10,000. The arms will cost \$18,000. The total cost is \$299,869. There will be no maintenance required in this area. The annual savings for this effort will be \$14,150.

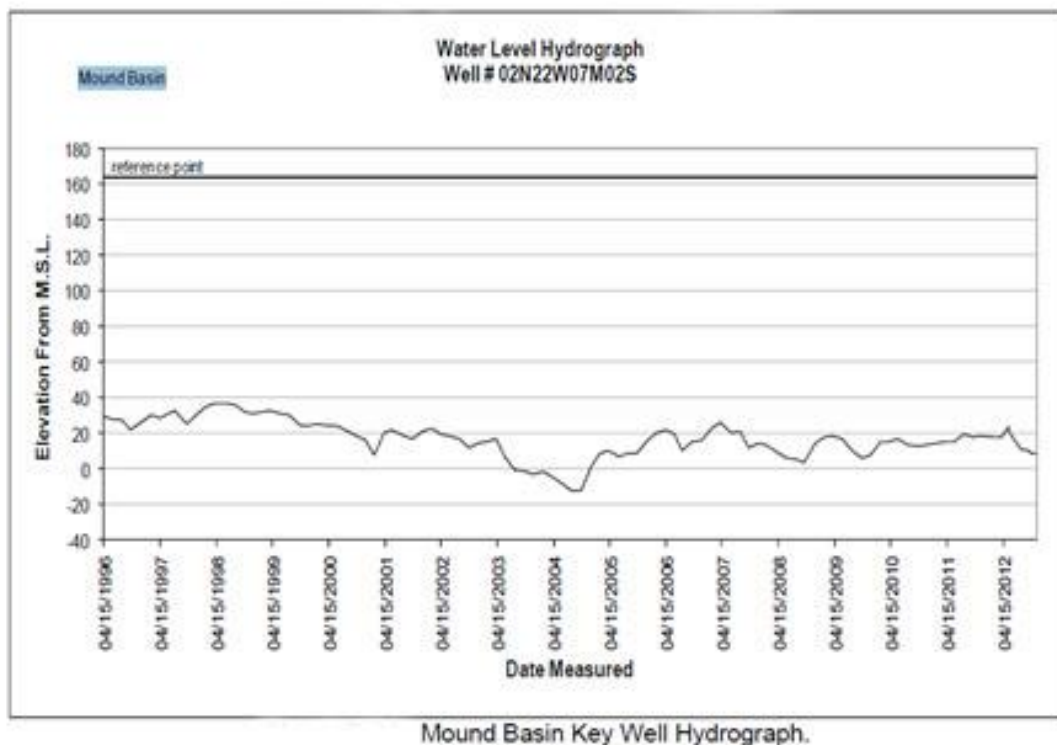
Figure 1-1

and located groundwater extraction near the center of the Mound Basin. A report (Fugro, 1997) compiled as part of a 1996 study of the basin indicated that historical data supports a basin yield of at least 8,000 AFY during drought conditions as long as pumpage is reduced during wet years to allow water levels to recover. The 1983 to 1996 average annual production from the Mound Basin was approximately 5,000 AFY (Fugro, 1997). While the resulting water levels in the basin over that time period reportedly ranged from significantly below sea level to a sufficient elevation about sea level to control seawater intrusion, the basin water level trend did not indicate an average production significantly above 5,000 AFY could be sustained without creating adverse conditions.⁷

Recharge to the subbasin is provided by percolation of surface flow in the Santa Clara River, Sespe Creek, and minor tributary streams. Some of the surface flow in the Santa Clara River originates as release from Lake Piru and contains natural runoff from precipitation and imported State Water Project water. Subsurface flow from Piru Subbasin, direct percolation of precipitation, and percolation of irrigation waters provide recharge as well.

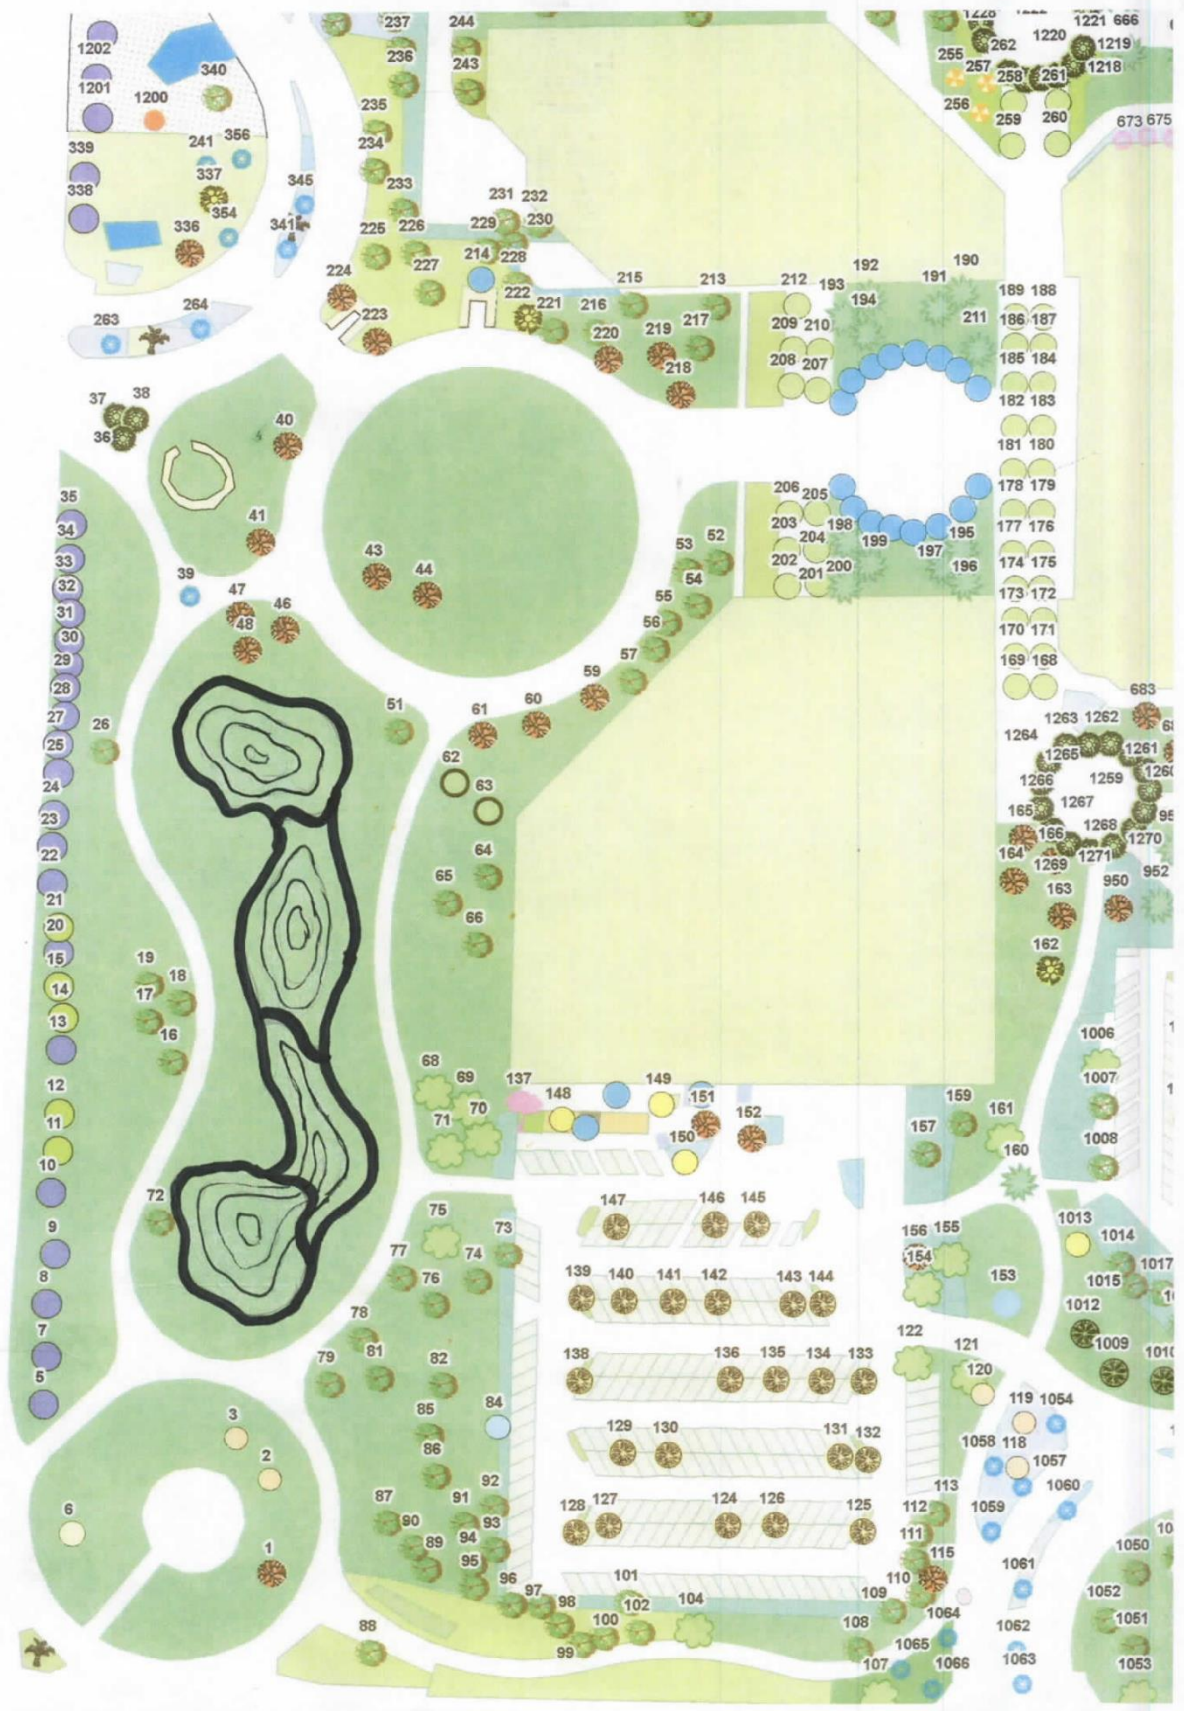
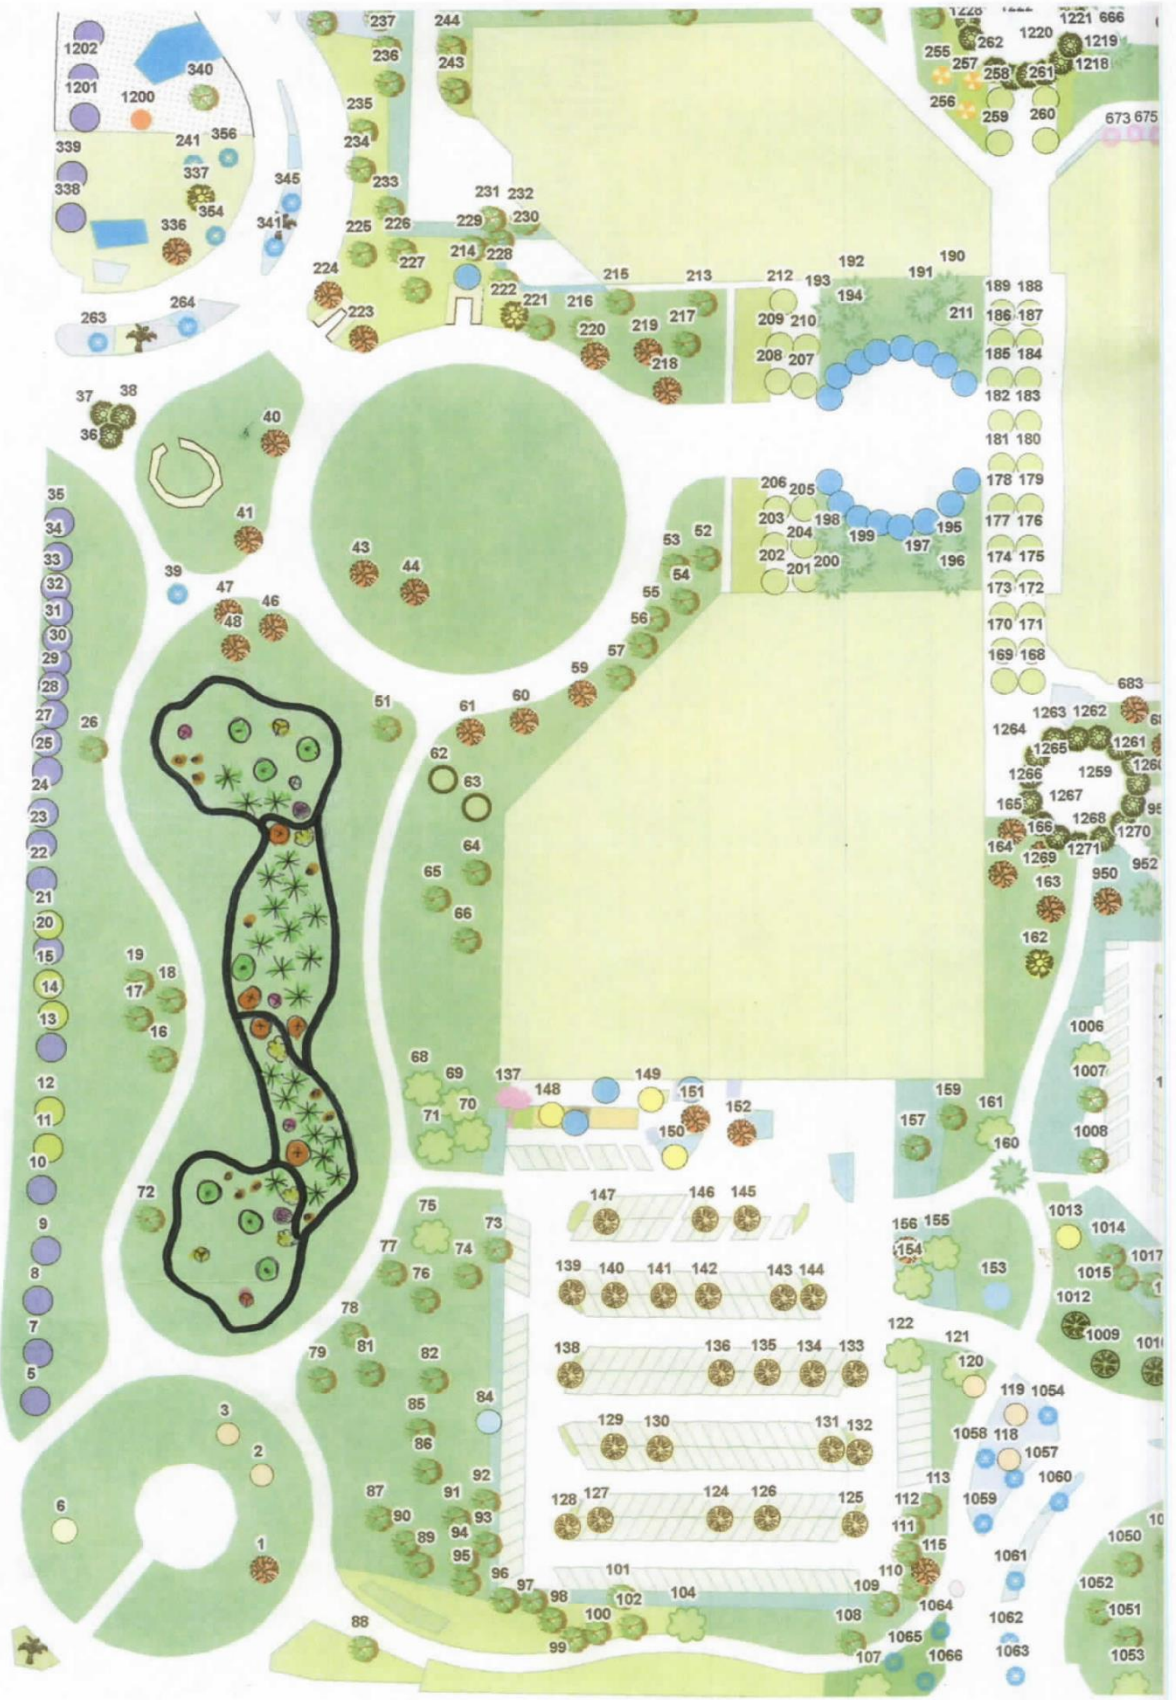
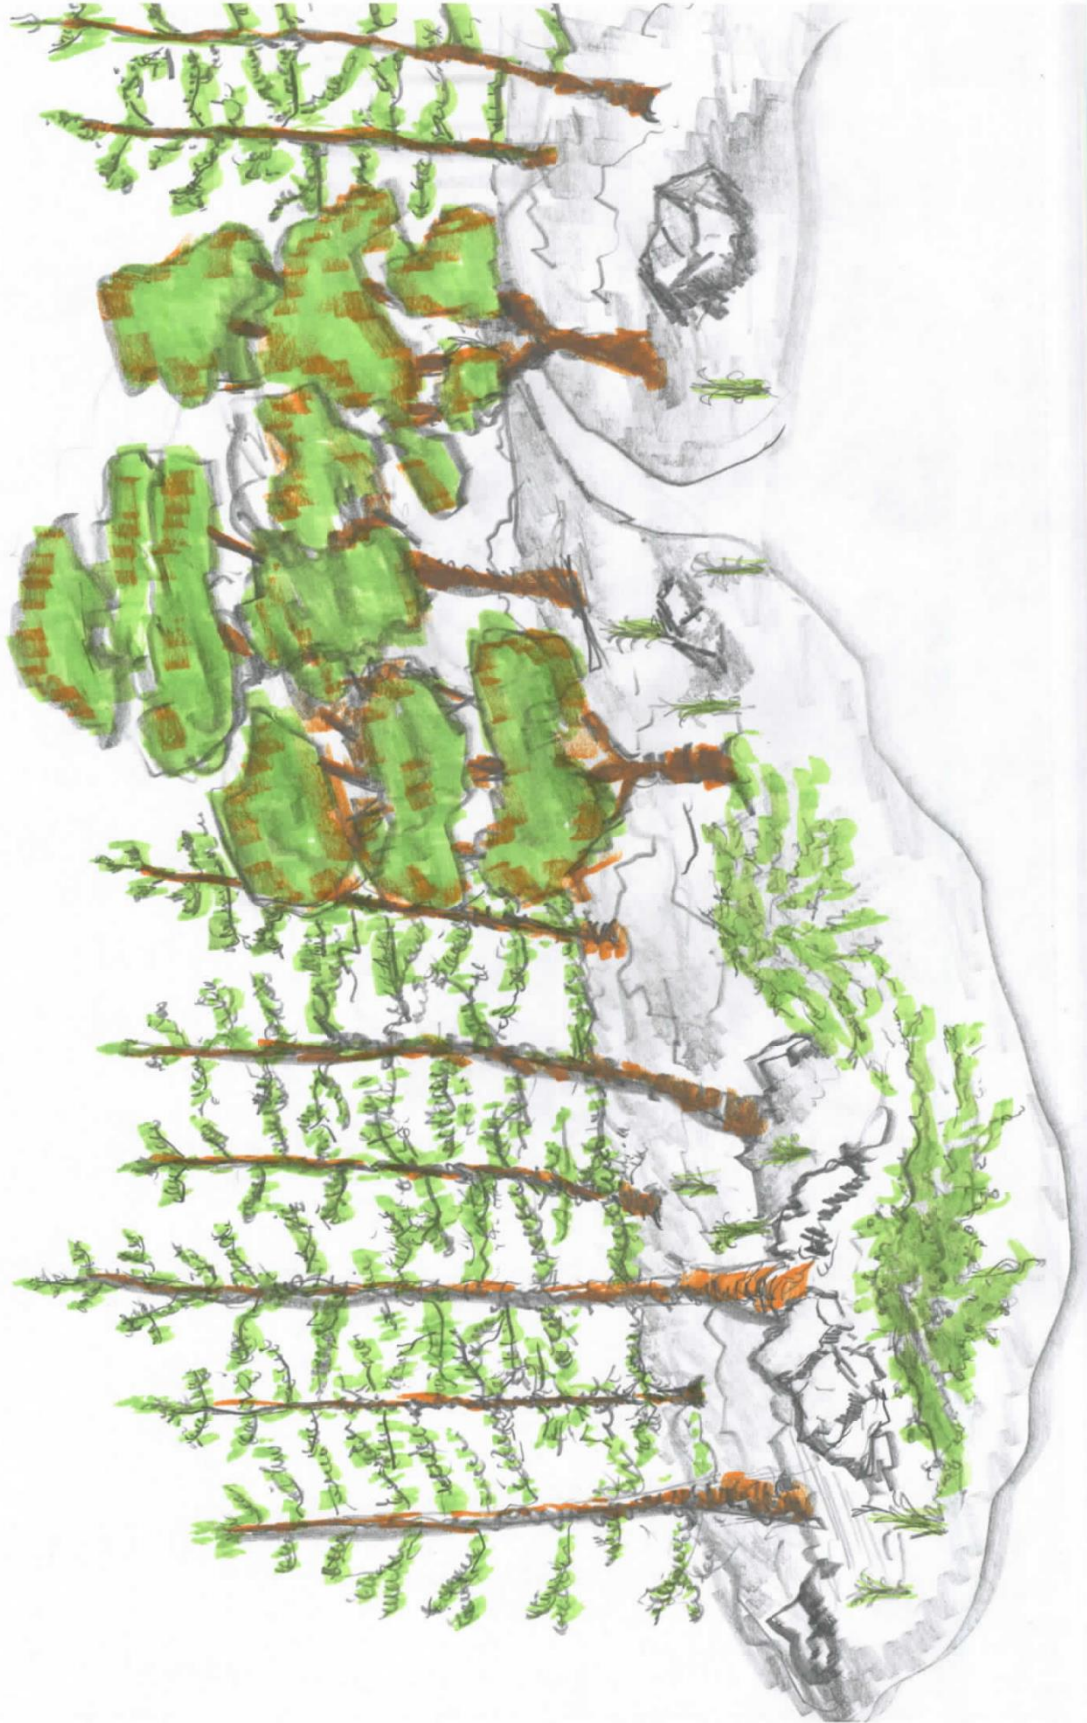
The following designs were created by Scott Flammer, GSA Grounds Supervisor
